Technical Newsletter

By: Technogym After Sales Service

No. 126 – July 2015

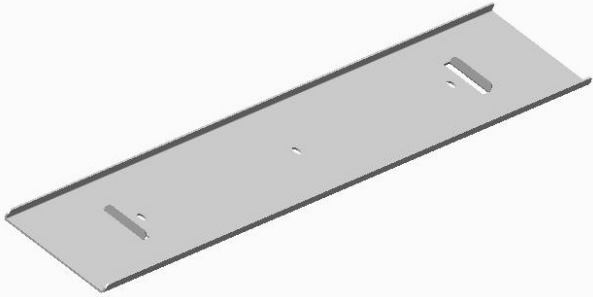
PARQUET FLOORS		
A0000799

In the previous newsletter (TN 2015/01), we communicated the code of the new plate **A0000799** to be placed below the rear feet of the machine, so it does not move when training, when used on parquet.

To be placed below the rear feet.
Or		
T0000994AA

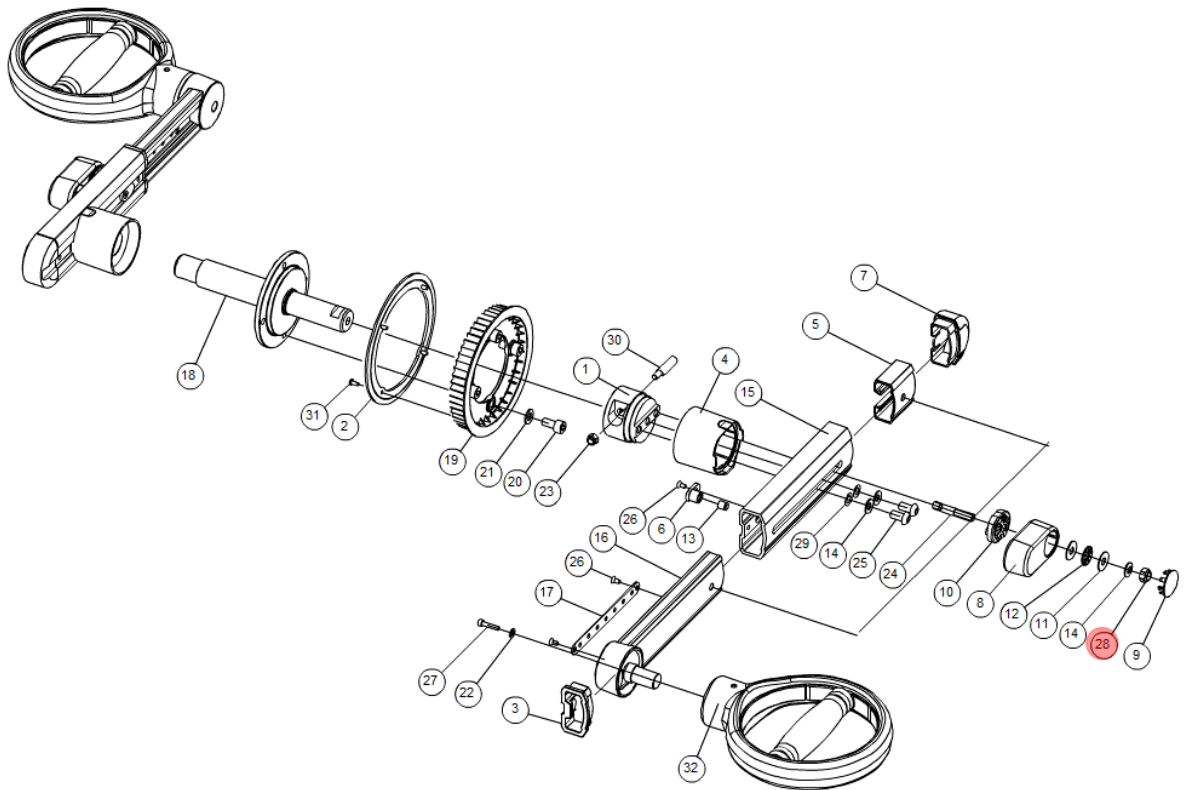
Loosening of the exercise lever adjustment knob

If the knob for blocking the exercise lever loosens it will no longer function properly. The cause is most likely a loose nut **ref.28**.

To keep this situation from repeating itself, apply a drop of Loctite 331 when tightening it.

The first machines produced with the use of Loctite on the nut have SN:

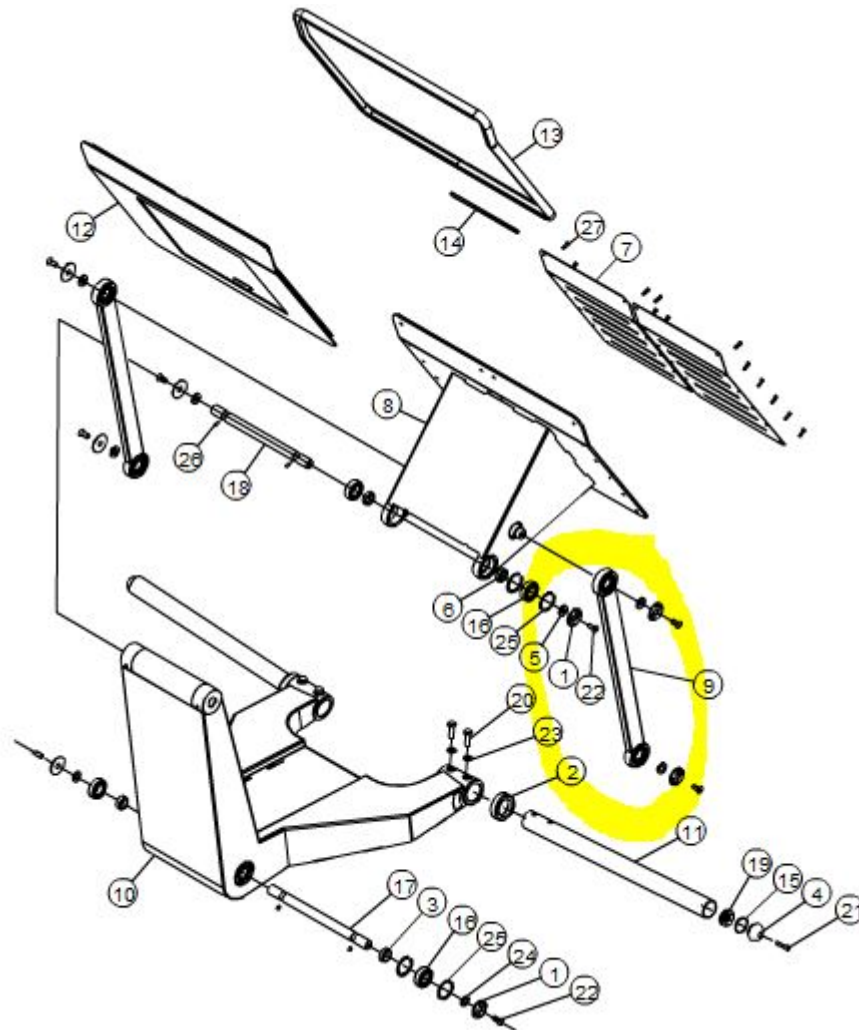
LEG PRESS: change to the foot plate leverage system

The mechanics for the foot plate have been changed, adding an additional symmetric lever to what is shown below, which is already present.

As shown in the figure, the new lever on the right side of the machine is the same as the one already present, and is fastened in the same way.

The first machine produced with this solution has SN **MG500015100248**.

It is not possible to install a second lever on previously produced machines, as the mounting holes are located both on the plate as well as on the frame.

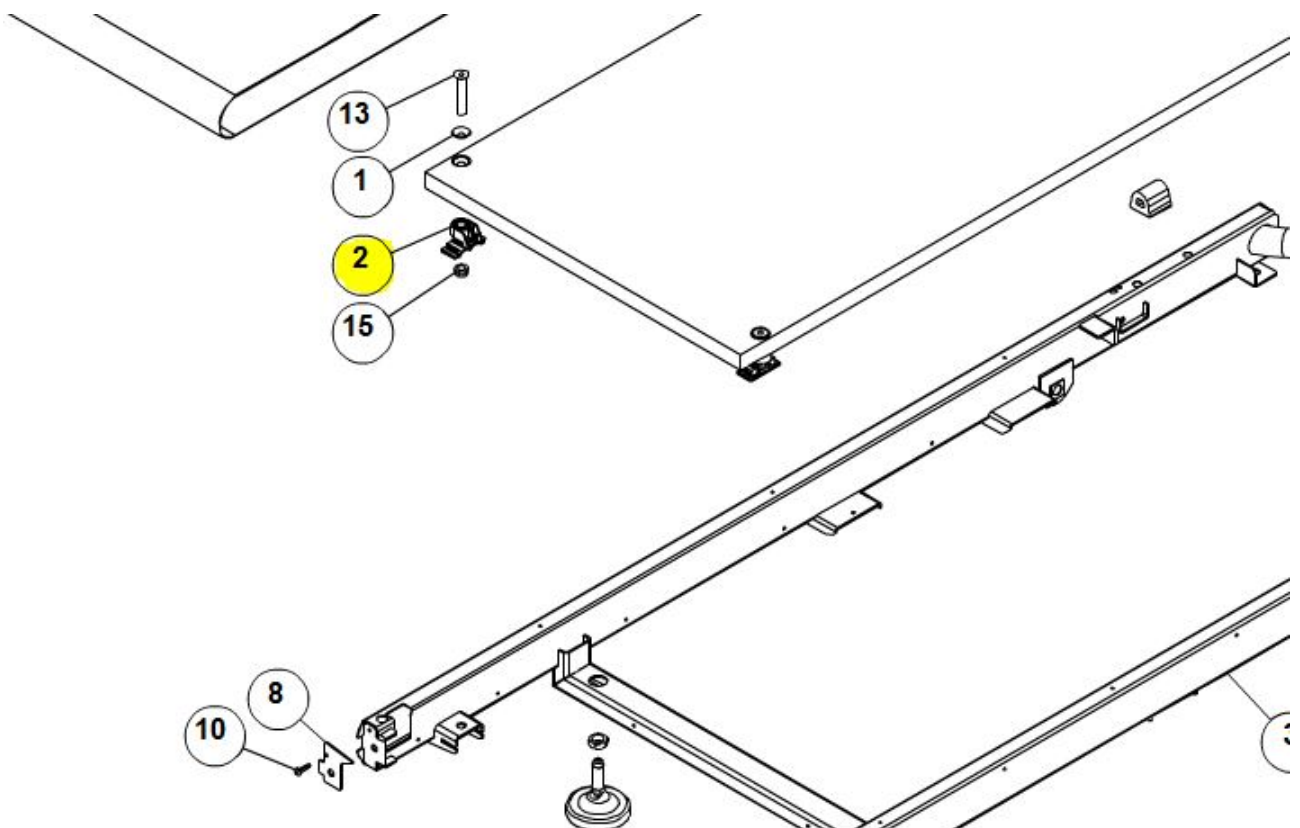
Machine noise due to belt sliding

In the case of machine noise coming from the belt during operation, due to its sliding until it comes into contact with the support spacers on the running deck, we suggest proceeding as follows.

1. Replace the rear roller. A new roller with a slightly modified profile is available which further limits the sliding of the belt during operation.
The code for this new roller, which is fully interchangeable with the previous one, is **T0000582AC**.
2. Replace the belt. The new belt, which has more restrictive tolerances, also limits possible sliding while working out.
The code for this new belt, which is fully interchangeable with the previous one, is **OK001078AA**.
WARNING: this belt must be installed with a tension of 7‰ (7 per thousand)
3. Replace the support spacers from the deck. Smaller spacers (ref. 2 in the figure below) are available that increase the belt movement area by a few mm, in the case of sliding.
The code for these new spacers, which are completely interchangeable with the previous ones, is **OC004226AA-NR**.

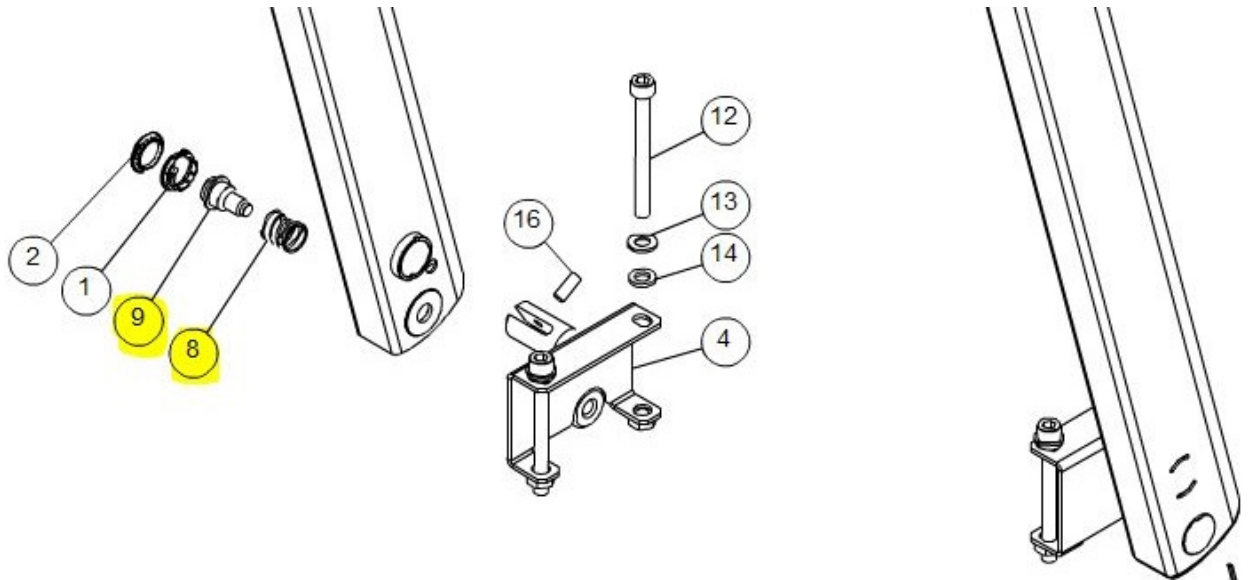
Display pole assembly problems

If it is difficult to assemble the display support poles, first remember that it is important to keep the pole aligned when tightening the first threaded pin.

If it is still not possible to screw the pin into the frame, the pin (ref.9) and the spring (ref.8) can be replaced with the new versions of the same components, which have been changed slightly to make assembly easier.

The new components are interchangeable, but both must be replaced. The codes for the 2 components are indicated below:

REF.	CODE	DESCRIPTION
8	OM000460AB	Spring
9	OP001920AD	Threaded pin

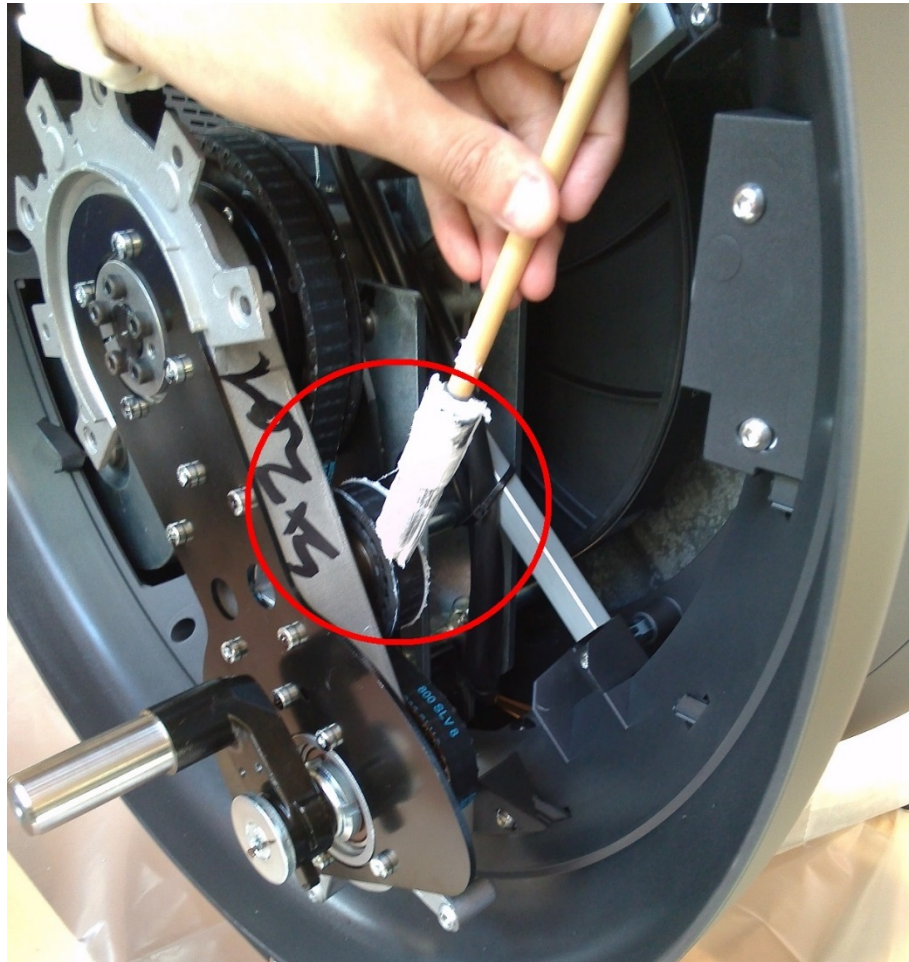
Rear transmission squeaking

In the case of noise, and in particular a squeaking noise coming from the rear transmission, check to see if it is being caused by one of the 2 transmission unit belts. The squeaking could be caused by the contact between the belt and the pulley, as shown below in the figure. To solve the problem, lubricate the edges of the pulley, using **OV000468AB** grease.
